# **Mobile Intel<sup>®</sup> Celeron<sup>®</sup> Processor at 466 MHz, 433 MHz, 400 MHz, 366 MHz, 333 MHz, 300 MHz, and 266 MHz Specification Update**

Release Date: January 2002

Order Number: 244444-029

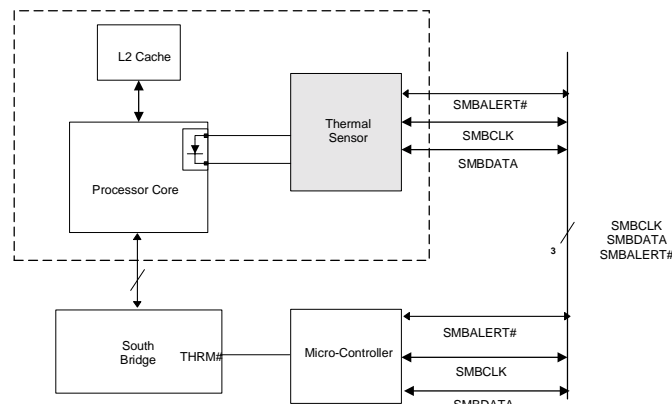
**Figure 1. An Example of Microcontroller Driven Thermal Management**

## H29. Thermal Sensor May Assert SMBALERT# Incorrectly

**Problem:** The Intel Celeron Processor Mobile Module has a thermal sensor that monitors the processor core's temperature. Please note that desktop systems could have a similar thermal device. The thermal sensor asserts SMBALERT# if the processor temperature exceeds the temperature limits set in the Alarm Threshold Registers ( $T_{HIGH}$ ,  $T_{LOW}$ ). It also sets the corresponding Status Register bits to identify the cause of the interrupt. Figure 1 gives one example of the how the SMBALERT# signal could be used in a system.

**Implication:** There is no system impact from this erratum if temperature polling is used for processor thermal management. If the SMBALERT# interrupt is employed to manage processor thermal sensing, then servicing the false interrupt may result in premature system action depending on the software and hardware implementations used. The rate of the false interrupts is less than the auto-convert rate of the thermal sensor.

**Workaround:** Three different (mutually exclusive) workarounds are possible:

1. Before servicing an interrupt from the thermal sensor, read and compare the processor thermal reading with the threshold limits ( $T_{HIGH}$  or  $T_{LOW}$ ). Figures 2 and 3 provide basic flowcharts for the implementation of this workaround in an interrupt driven system.
2. If the firmware implemented polls the Status Register only, then before taking any action, re-read the temperature register and do a comparison with the alarm threshold limits ( $T_{HIGH}$  or  $T_{LOW}$ ) to determine if the value is actually still within the temperature window.
3. Use a temperature polling scheme to monitor the processor temperature.
